DEPARTMENT OF TRANSPORTATION**DIVISION OF ENGINEERING SERVICES**

Contract #: 04-0120F4Cty: SF/ALA Rte: 80 PM: 13.2/13.9File #: 69.28**WELDING INSPECTION REPORT****Resident Engineer:**Siegenthaler, Peter**Address:** 333 Burma Road**City:** Oakland, CA 94607**Report No:** WIR-017954**Date Inspected:** 12-Nov-2010**Project Name:** SAS Superstructure**OSM Arrival Time:** 700**Prime Contractor:** American Bridge/Fluor Enterprises, a JV**OSM Departure Time:** 1900**Contractor:** Zhenhua Port Machinery Company, Ltd (ZPMC), Changxing Island **Location:** Shanghai, China**CWI Name:** Liu Fa Wen**CWI Present:** Yes No**Inspected CWI report:** Yes No N/A**Rod Oven in Use:** Yes No N/A**Electrode to specification:** Yes No N/A**Weld Procedures Followed:** Yes No N/A**Qualified Welders:** Yes No N/A**Verified Joint Fit-up:** Yes No N/A**Approved Drawings:** Yes No N/A**Approved WPS:** Yes No N/A**Delayed / Cancelled:** Yes No N/A**Bridge No:** 34-0006**Component:** OBG Components**Summary of Items Observed:**

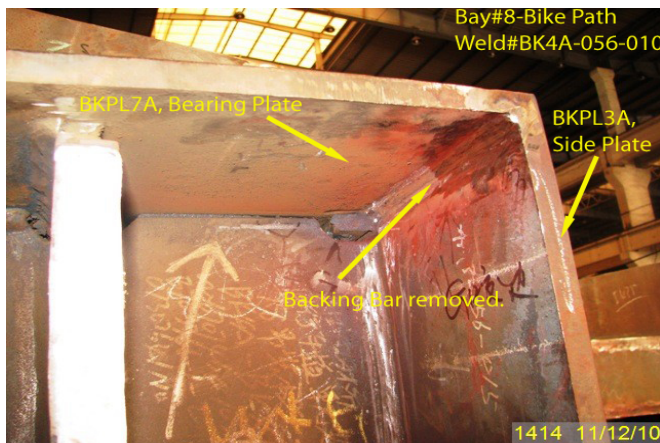
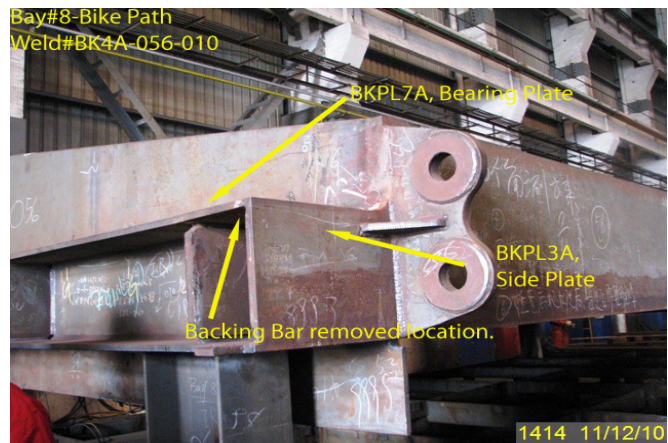
During random in process visual inspection of the bike path component, this QA inspector observed the following issue;

- ZPMC personnel was removed the steel backing bar from the CJP weld.
- According to the Weld Detail drawing, this weld is CJP with steel backing bar.
- After complete welding of this weld with steel backing bar, CT QA inspector observed the excessive root opening between steel backing bar and the base plate. (For more information, please review the incident report#1648, generated on 10/28/2010)
- The steel backing bar was removed by carbon arc gouging from the area having a more root opening (more than 6mm).
